Research Demonstrates Performance of Permeable Interlocking Concrete Pavements

High-Impact Results from Low-Impact Development

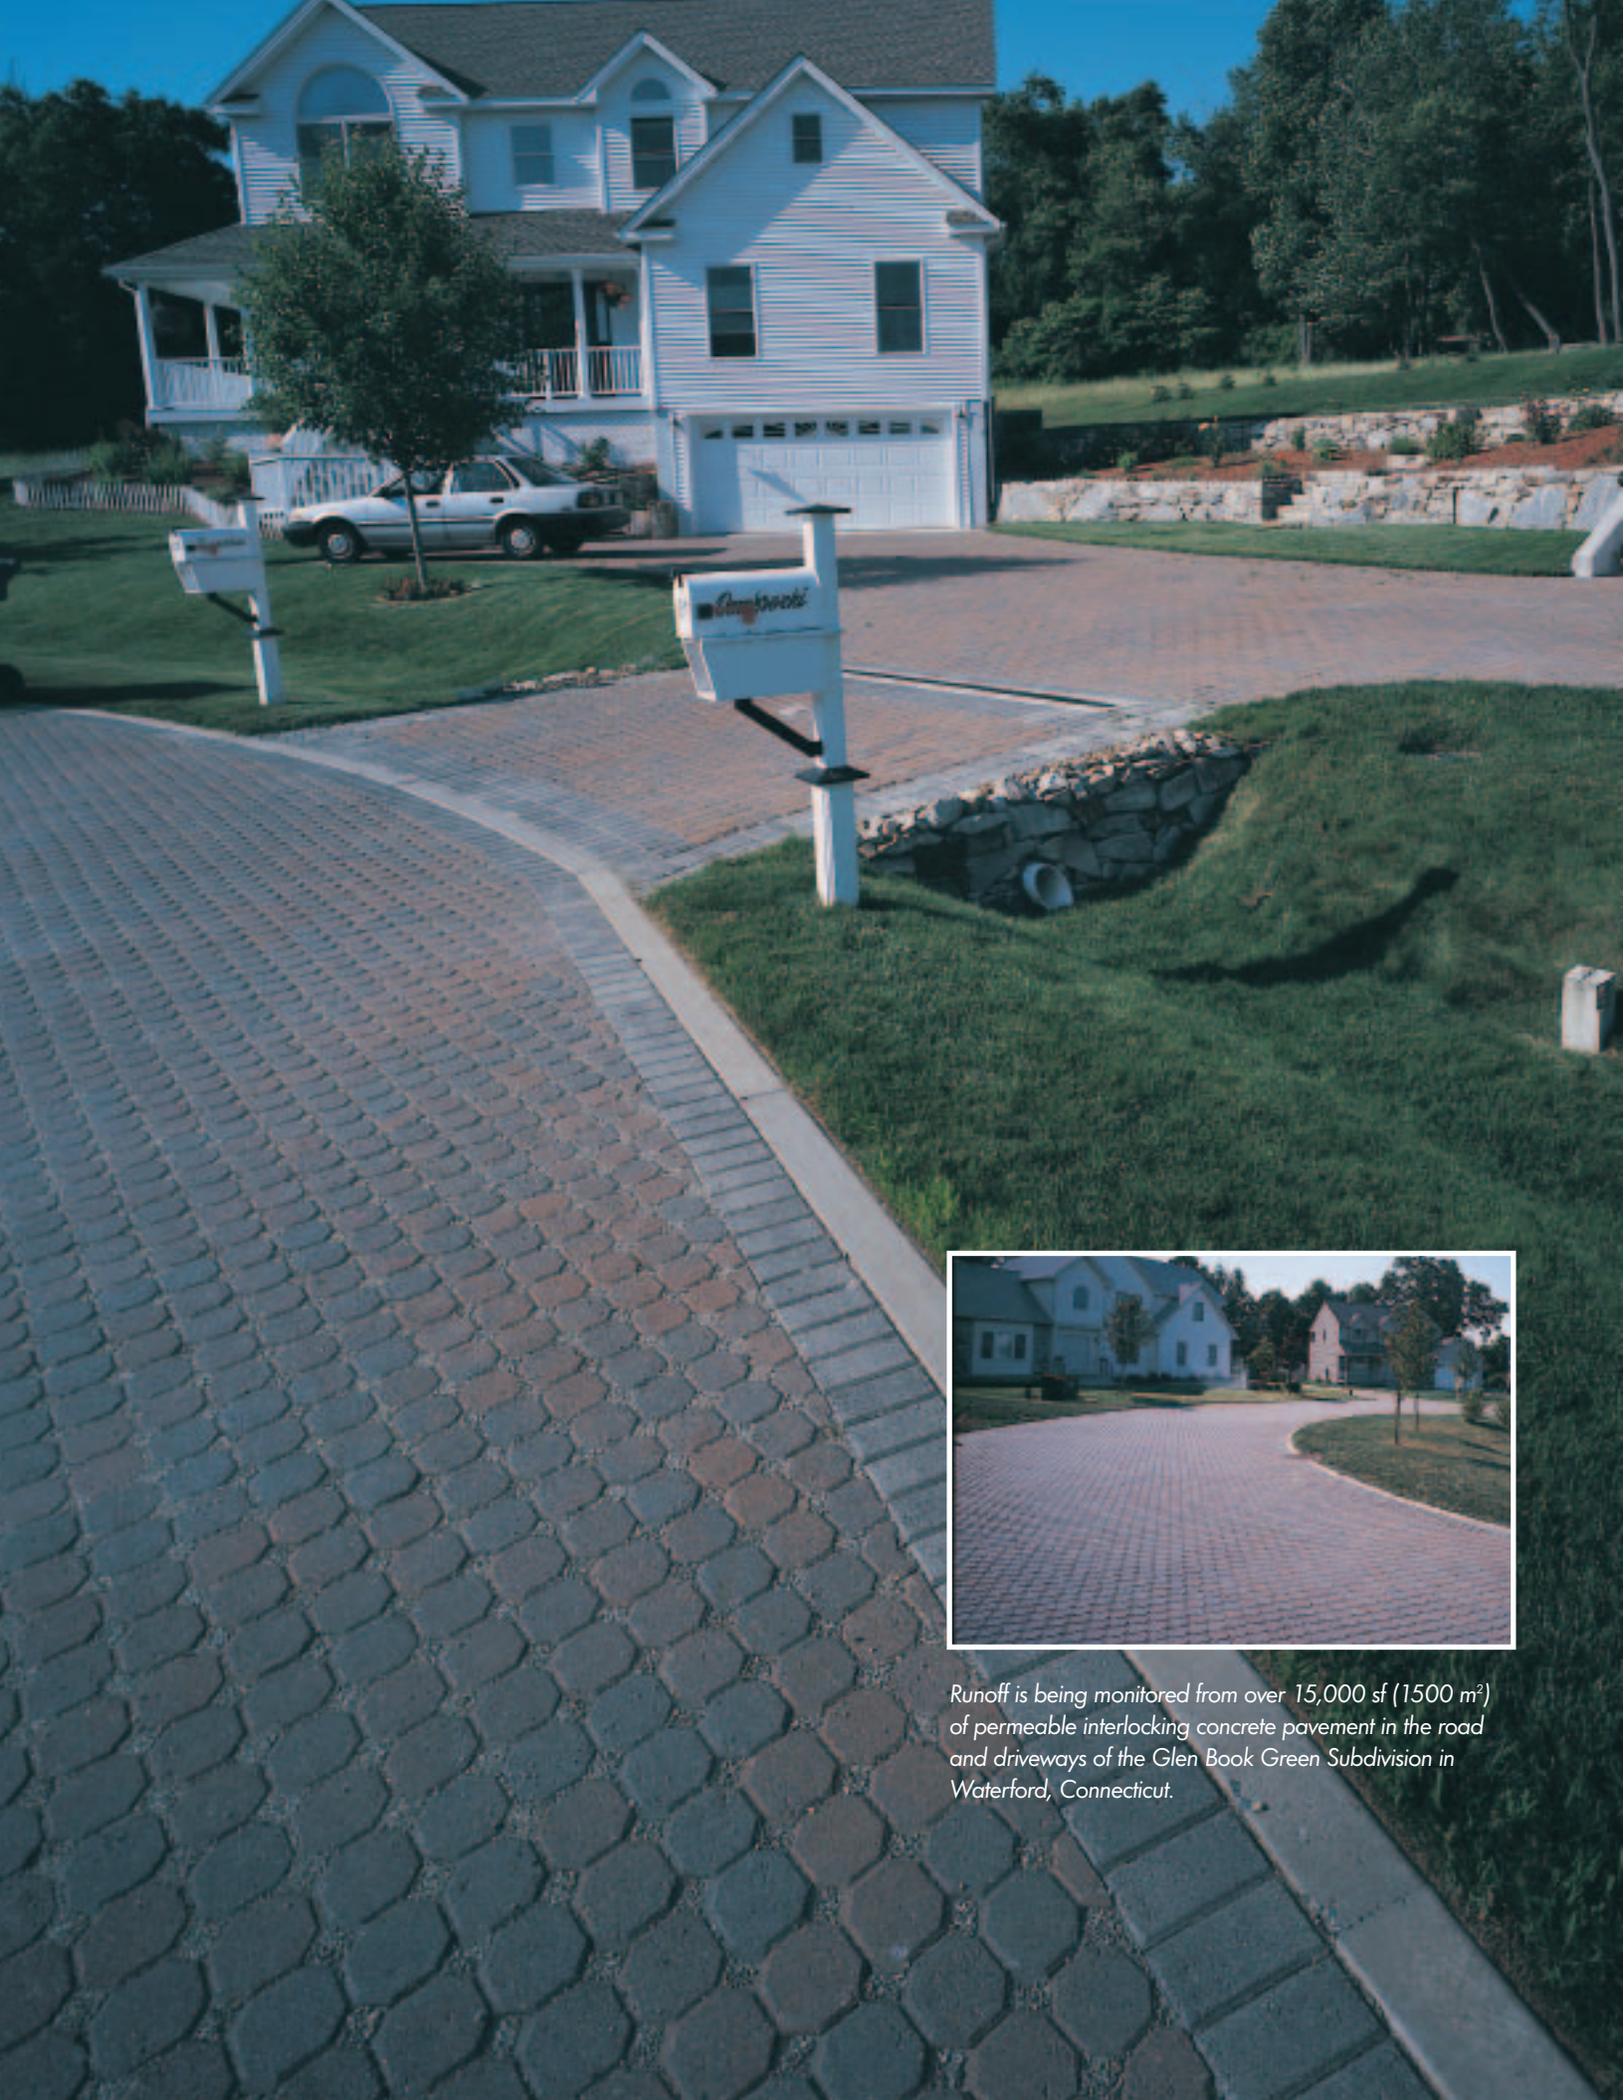
Runoff is being monitored from over 15,000 sf (1500 m²) of permeable interlocking concrete pavement in the road and driveways of the Glen Book Green Subdivision in Waterford, Connecticut.

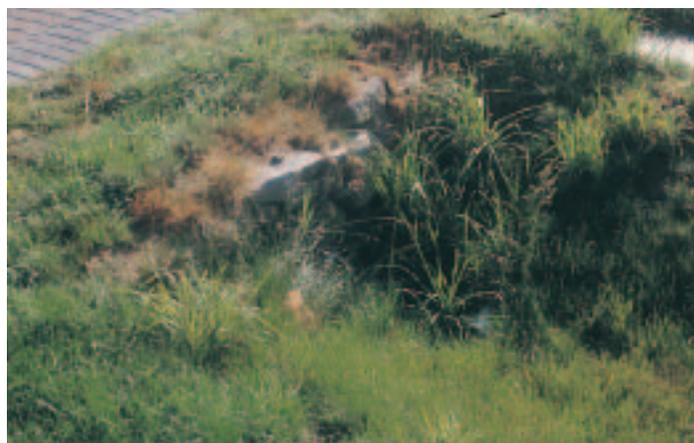
Figure 3. Grass swales rather than curb and gutters enable water to infiltrate and reduce the erosive effects from rapid discharges into streams.

A 6.9 acre (2.8 ha) area of residential homes uses best management practices (BMPs) including PICP intended to reduce water pollution and runoff. A third residential area of 13.9 acres (5.6 ha) serves as a control for the multi-year monitoring program. Besides PICP, the BMP area includes several management practices such as using grass swales instead of curb and gutters and rain gardens or areas for runoff to infiltrate into the soil. Figures 3 and 4 show examples of these BMPs.

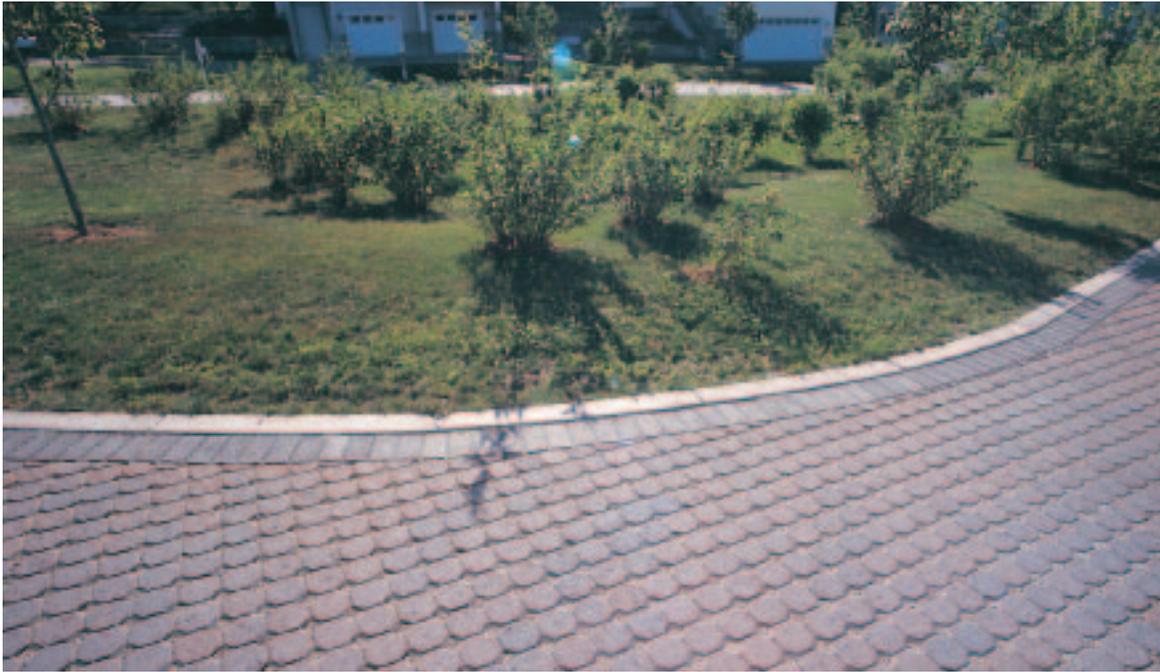
Figure 4. A rain garden in the center of the cul-de-sac soaks up runoff in a space that would otherwise be paved with an impervious surface.
