Research Demonstrates Performance of Permeable Interlocking Concrete Pavements

High-Impact Results from Low-Impact Development

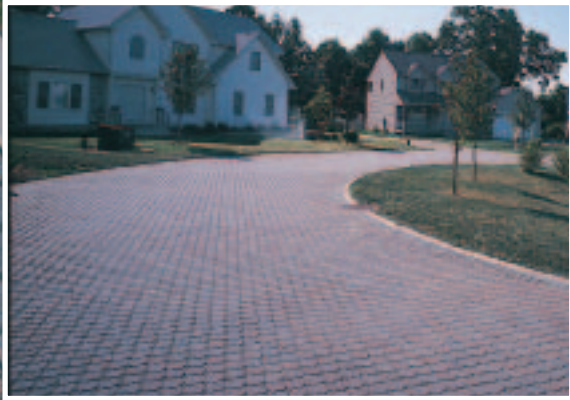
Runoff is being monitored from over 15,000 sf (1500 m²) of permeable interlocking concrete pavement in the road and driveways of the Glen Book Green Subdivision in Waterford, Connecticut.

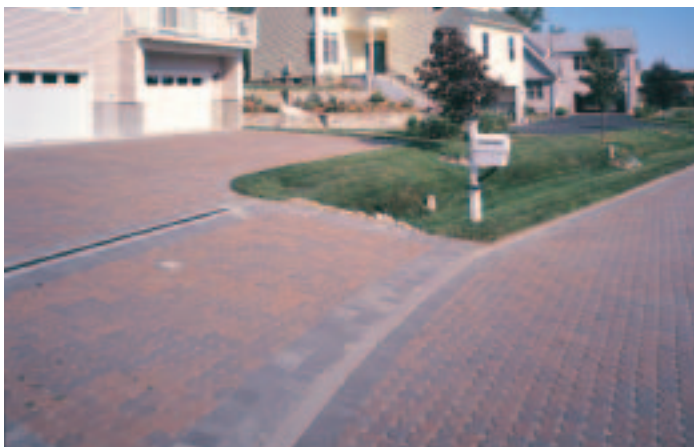
Figure 2. Slot drains at the ends of the PICP driveways facilitated sampling and collection of runoff.

“The data looks impressive,” says Bruce Morton with AquaSolutions, a private ecosystem management company that provides guidance on the runoff monitoring project. “The permeable pavement has a direct benefit in this project by reducing runoff and water pollutants.” He further noted that runoff from the driveways was sampled from drains at their ends. Figure 2 shows a typical drain location.

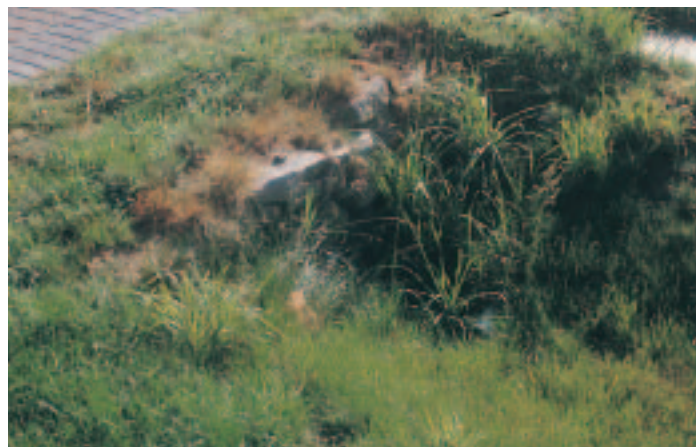
Figure 3. Grass swales rather than curb and gutters enable water to infiltrate and reduce the erosive effects from rapid discharges into streams.

A 6.9 acre (2.8 ha) area of residential homes uses best management practices (BMPs) including PICP intended to reduce water pollution and runoff. A third residential area of 13.9 acres (5.6 ha) serves as a control for the multi-year monitoring program. Besides PICP, the BMP area includes several management practices such as using grass swales instead of curb and gutters and rain gardens or areas for runoff to infiltrate into the soil. Figures 3 and 4 show examples of these BMPs.

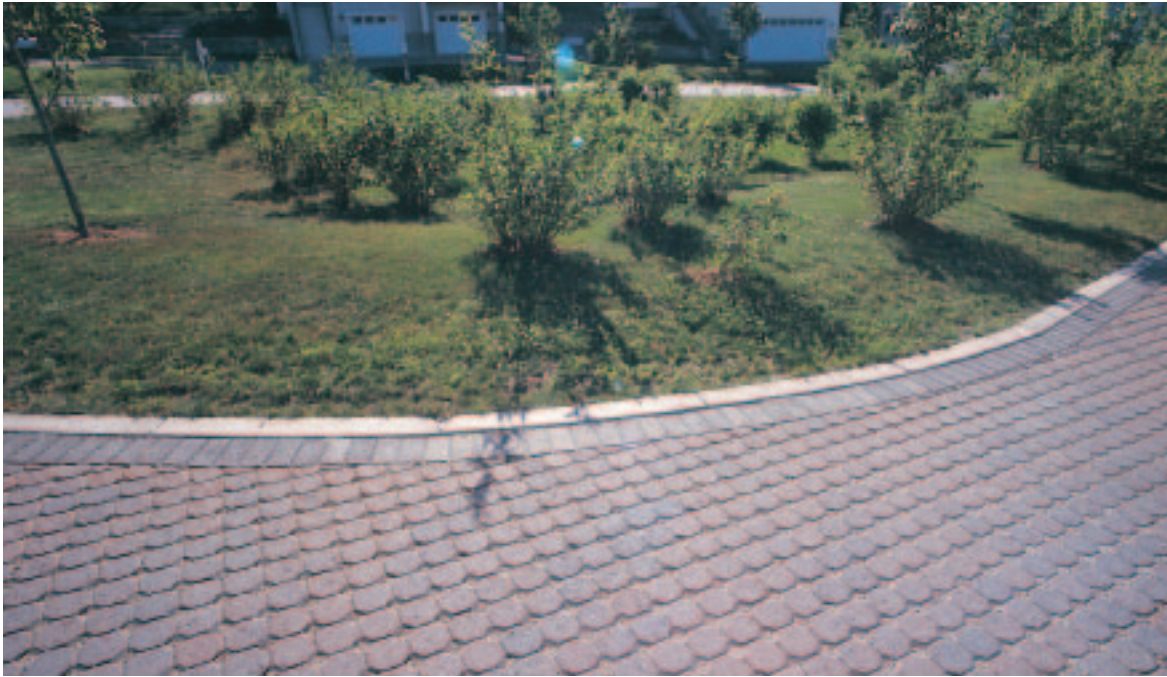
Figure 4. A rain garden in the center of the cul-de-sac soaks up runoff in a space that would otherwise be paved with an impervious surface.
