Evaluation of Permeable Pavements in Cold Climates

Kortright Centre, Vaughan

Final Report

December 2012

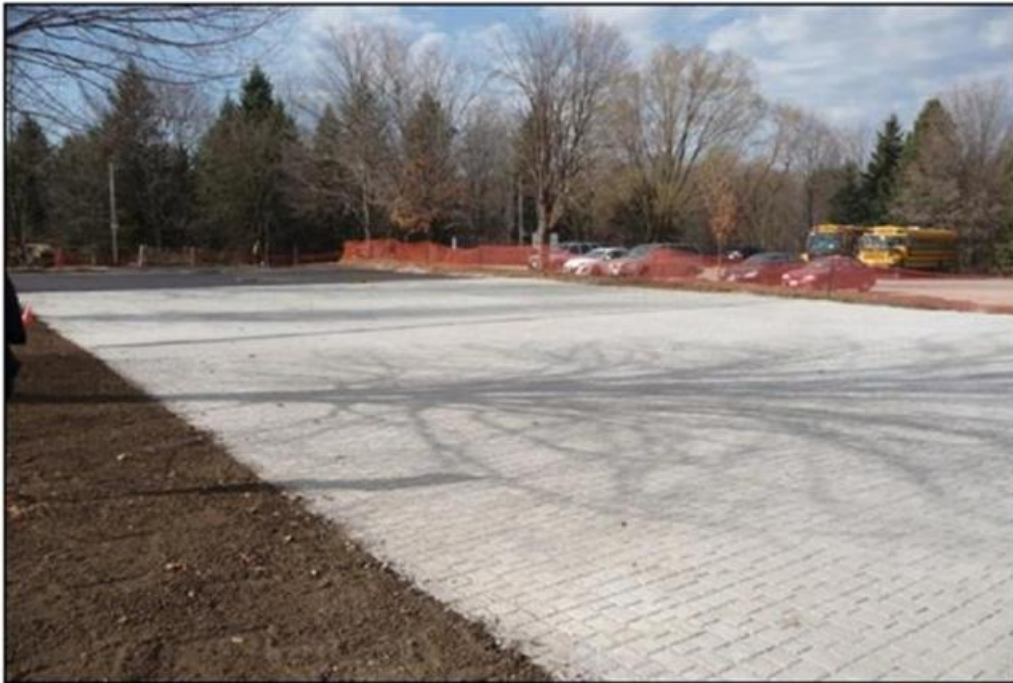
Figure 3.1: Kortright permeable pavements

In 2009, one of the parking bays was replaced with new permeable and impermeable pavements. The new permeable pavement parking lot, shown in Figure 3.1, consists of four 230–233 m² pavement cells. Two cells were constructed with permeable interlocking concrete pavers (AquaPave[®] and Eco-Optiloc[®]), one cell was constructed with Pervious Concrete and one cell was constructed with traditional asphalt. The clear stone granular base for the permeable pavements provides roughly 49 cm of storage. A schematic of the facility is shown in Figure 3.2 and outlines the location of the 4 pavement cells and general location of the drainage pipes. A description of the construction and photographs of the new parking bay is provided in Appendix A.

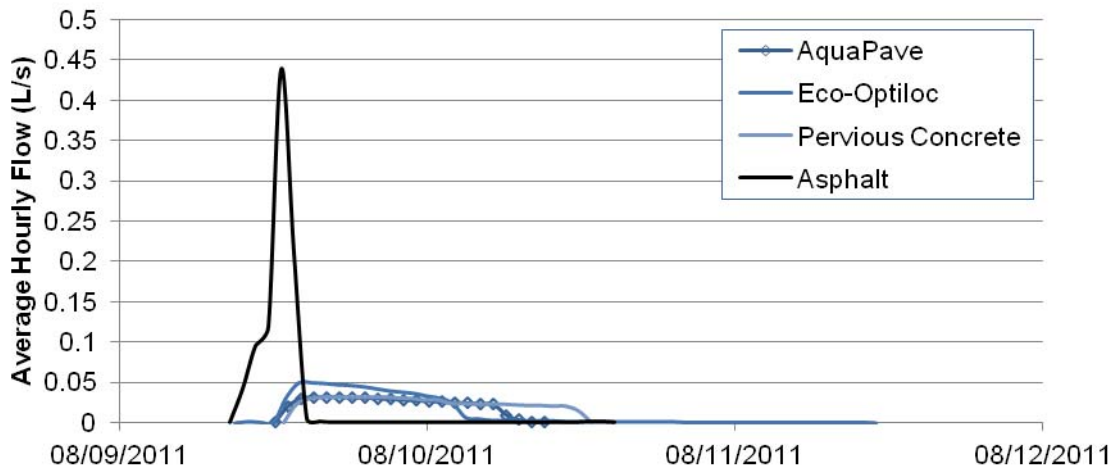
Figure 6.2: Event hydrographs: (a) October 2, 2011 (7.4 mm), (b) August 9, 2011 (15 mm) and (c) June 23, 2011 (49 mm)

Sample hydrographs of the PP and asphalt for small, medium and large rain events are shown in Figure 6.2. Table 6.3 summarizes outflow and runoff volumes and peak flow rates. More detailed tables are presented in Appendix B including total volumes (V_T), peak flows (Q_p) and associated reductions (VR and QR) for storm and melt events that initiated outflow from the PP underdrains, as well as runoff V_T and Q_p for events that did not produce PP outflow. Four summer events (June 11th, 23rd, August 14th, 2011; June 21, 2012) had negative volume reductions (*i.e.* the volume of stormwater exiting the PPs was larger than the volume of runoff). These results are attributed to malfunctioning equipment which underestimated the volume of runoff. Overall, the PPs reduced the total volume of stormwater outflow by 42%. Throughout the study, the PPs reduced peak flows by between 50 and 100%. The PPs continued to provide peak flow reductions throughout the winter and overall the median QR was 91%. Even larger QR values would have been observed if the asphalt outlet had not been restricted by the gate valve.

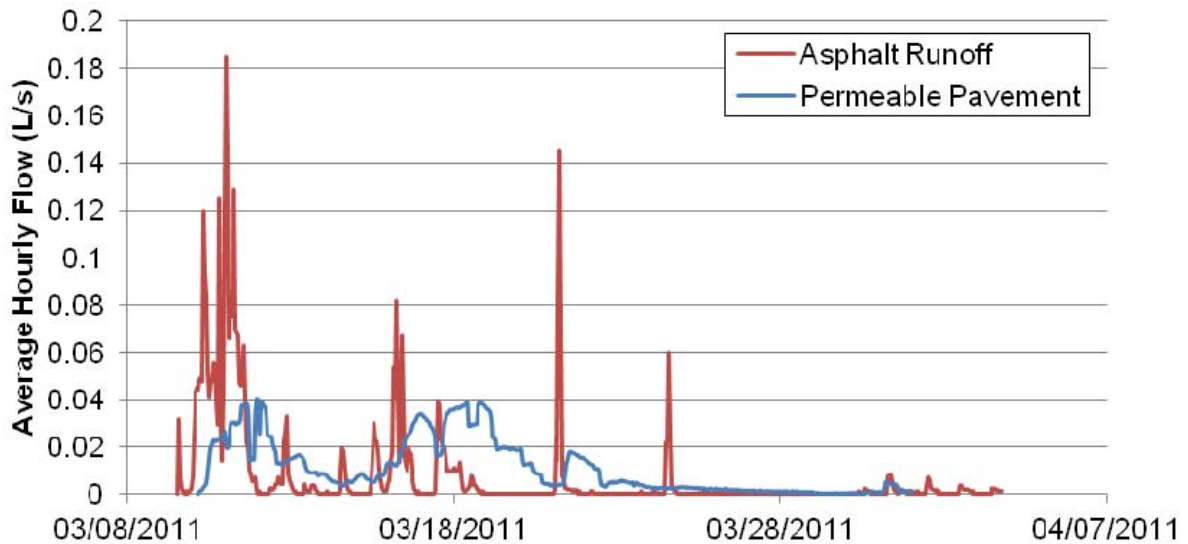
Figure 6.4: Spring thaw hydrographs of asphalt surface runoff and permeable pavement underdrain flows

asphalt runoff. The increase in total volume is attributed to a couple of factors. First, water from two smaller thaw events on February 28th and March 4th did not fully drain or infiltrate prior to the major thaw event starting on March 9th. Hence, some of the water detained within the aggregate reservoir during these events was released later during the March 9th event (Figure 6.5). When all three events are considered, the stormwater volume exiting the PP underdrains was 7% less than the asphalt runoff. Second, snow was piled in the far corners of the PC cell which was a source of additional inflow that was not equally shared with the asphalt pavement. As illustrated in Figure 6.4 even though the PP had large spring thaw volumes, the infiltrated stormwater was well attenuated and the centroid of the spring thaw was delayed by approximately 3 days. Peak flow from the PP system was also reduced by 85% during this thaw.

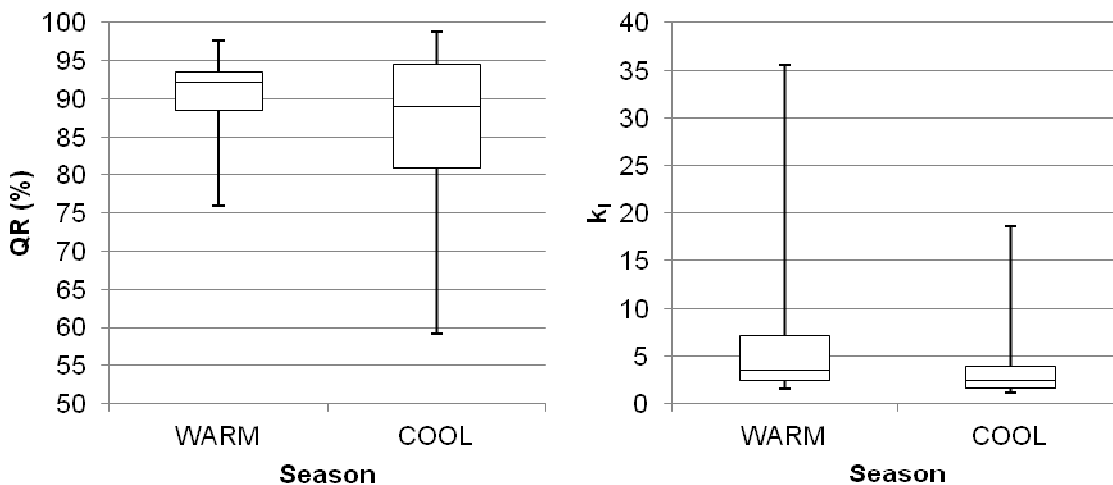
Figure 6.6: Seasonal peak flow reduction and lag coefficient boxplots

Comparing hydrologic variables between a warm (May-September) and cool (October-April) season reveal some differences in performance. Peak flow reductions are slightly larger and less variable during the warm season (Figure 6.6), although the PPs continued to provide large reductions, QR >60%, throughout the cool season. Slow release of water during winter melt events contributed to higher cool season peak flow variability. The relative delay of stormwater, represented by k_t , also tended to be longer during the warm season compared to the cool season but the summer months also displayed higher variability overall.

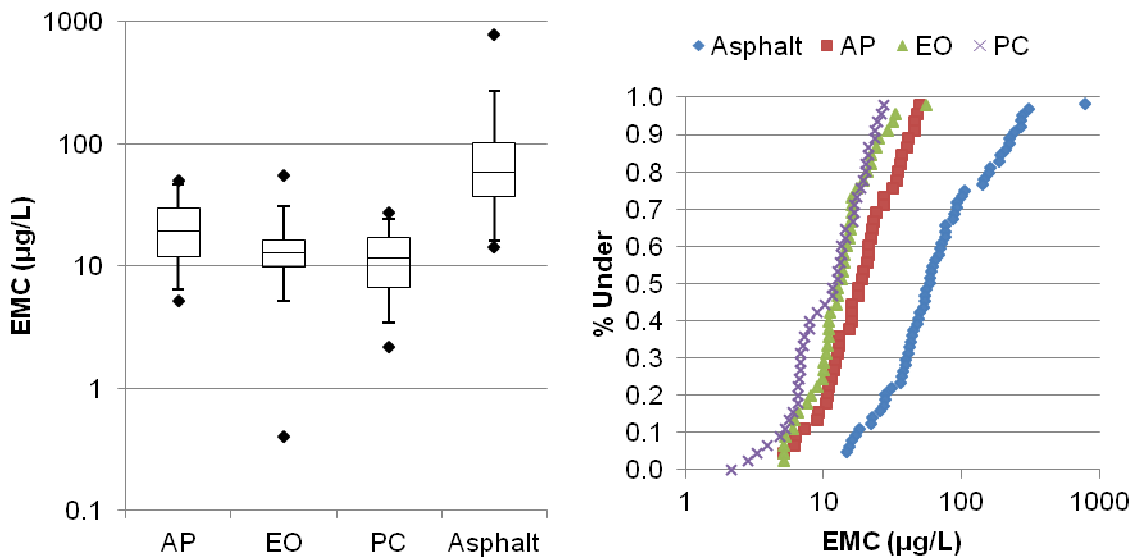
Figure 6.10: Zinc EMC; box plot (left), probability plot (right)

To highlight the water quality improvements provided by the PPs, boxplots and effluent probability plots were created for zinc concentrations (Figure 6.10). As with most of the water quality data, zinc concentrations tended to be log-normally distributed. Paired t-tests between the PPs and asphalt zinc data found statistically-significant reductions ($\alpha = 0.05$) of the log-transformed mean for AP ($p = 1.2 \text{ E-}8$), EO ($p = 4.2 \text{ E-}12$) and PC ($p = 3 \text{ E-}15$). The median removal efficiency for zinc was 69% (AP), 75% (EO) and 80% (PC) which is comparable to other PP studies (Rushton, 2001; Sansalone and Teng, 2004; TRCA 2008). The interim PWQO for the protection of aquatic life in receiving waters is 20 $\mu\text{g/L}$ for zinc, the PP outflow was more likely to meet this objective than runoff from the asphalt plot. Eighty six percent ($n=55$) of asphalt runoff samples exceeded the PWQO, whereas only 40% of samples ($n=17$) from AP, 18% of samples ($n=8$) from EO, and 18% of samples ($n=8$) from PC exceeded this objective.

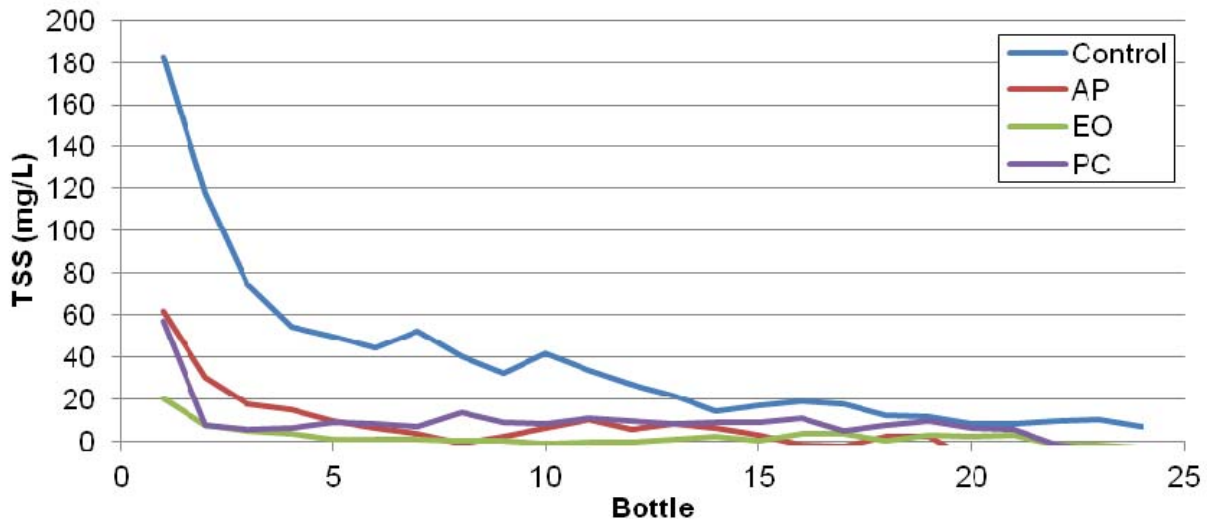
Figure 6.13: Intra-event TSS averaged from six monitored events

Six events were sampled to investigate intra-event patterns in water quality to determine how concentrations from the different pavements change over the course of the event. Twenty-four water samples were collected with the automated samplers during each event. Discrete samples were analyzed for turbidity and TSS. The duration of sampled events is 48 hours for PPs but only 2 hours for the runoff. As shown in Figure 6.13, runoff from the control plot exhibits a strong first flush pattern and TSS rapidly declines after the first few bottles. A small 'first flush' is observed in the AP and PC stormwater but it is considerably muted when compared with the asphalt runoff. The smaller first flush from the PPs is attributed to filtration through the pavements and the delay of runoff initiation caused by storage and infiltration of the first 5 to 7 mm of rain events.

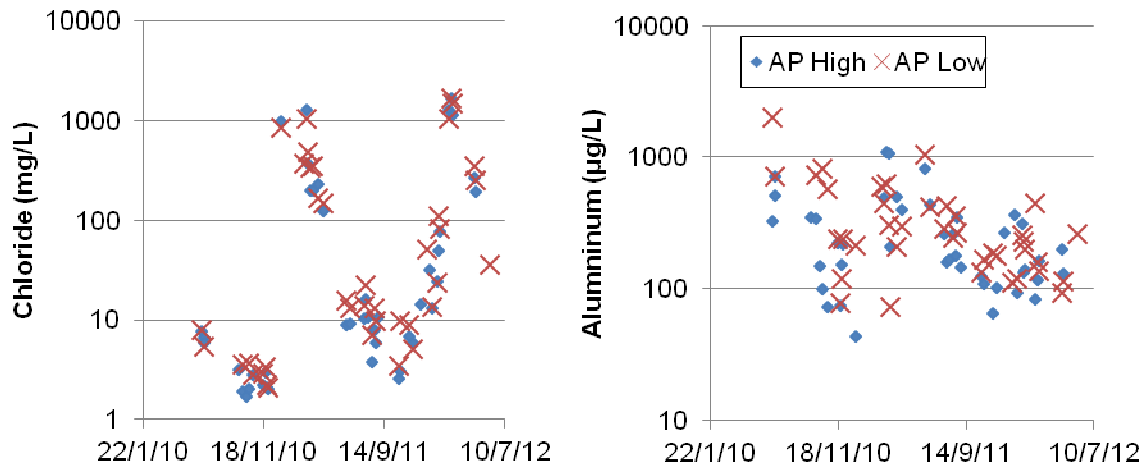
Figure 6.15: Sample concentrations for AquaPave High and AquaPave Low: Chloride (left), Aluminum (right)

Water samples for 39 events were collected to compare the quality of infiltrated stormwater at the base of the AP pavement, referred to as AquaPave High (APH), to the quality of stormwater that had infiltrated through a section of native material (approx. 0.5 to 0.7 m below the upper pipe), referred to as AquaPave Low (APL). Pollutant concentrations in APH and APL samples are strongly correlated. Some pollutants, such as chloride, move freely through the native soil with minimal retention (Figure 6.15). The native soil also appears to be experiencing stabilization and concentrations of aluminum and iron have consistently declined over the course of the monitoring period (Figure 6.15). Seasonal trends are visible for some nutrients and metals with concentrations in APL matching concentrations in APH (Figure 6.16). Normally, pollutant concentrations that adsorb to soil particles, such as lead and phosphorus, would be expected to decrease as the water is infiltrated through soil media. The similarity of pollutant concentrations in APH and APL samples suggests that the soil depth between the APH and APL may not have been sufficient to adsorb or trap pollutants and/or short circuiting through cracks in

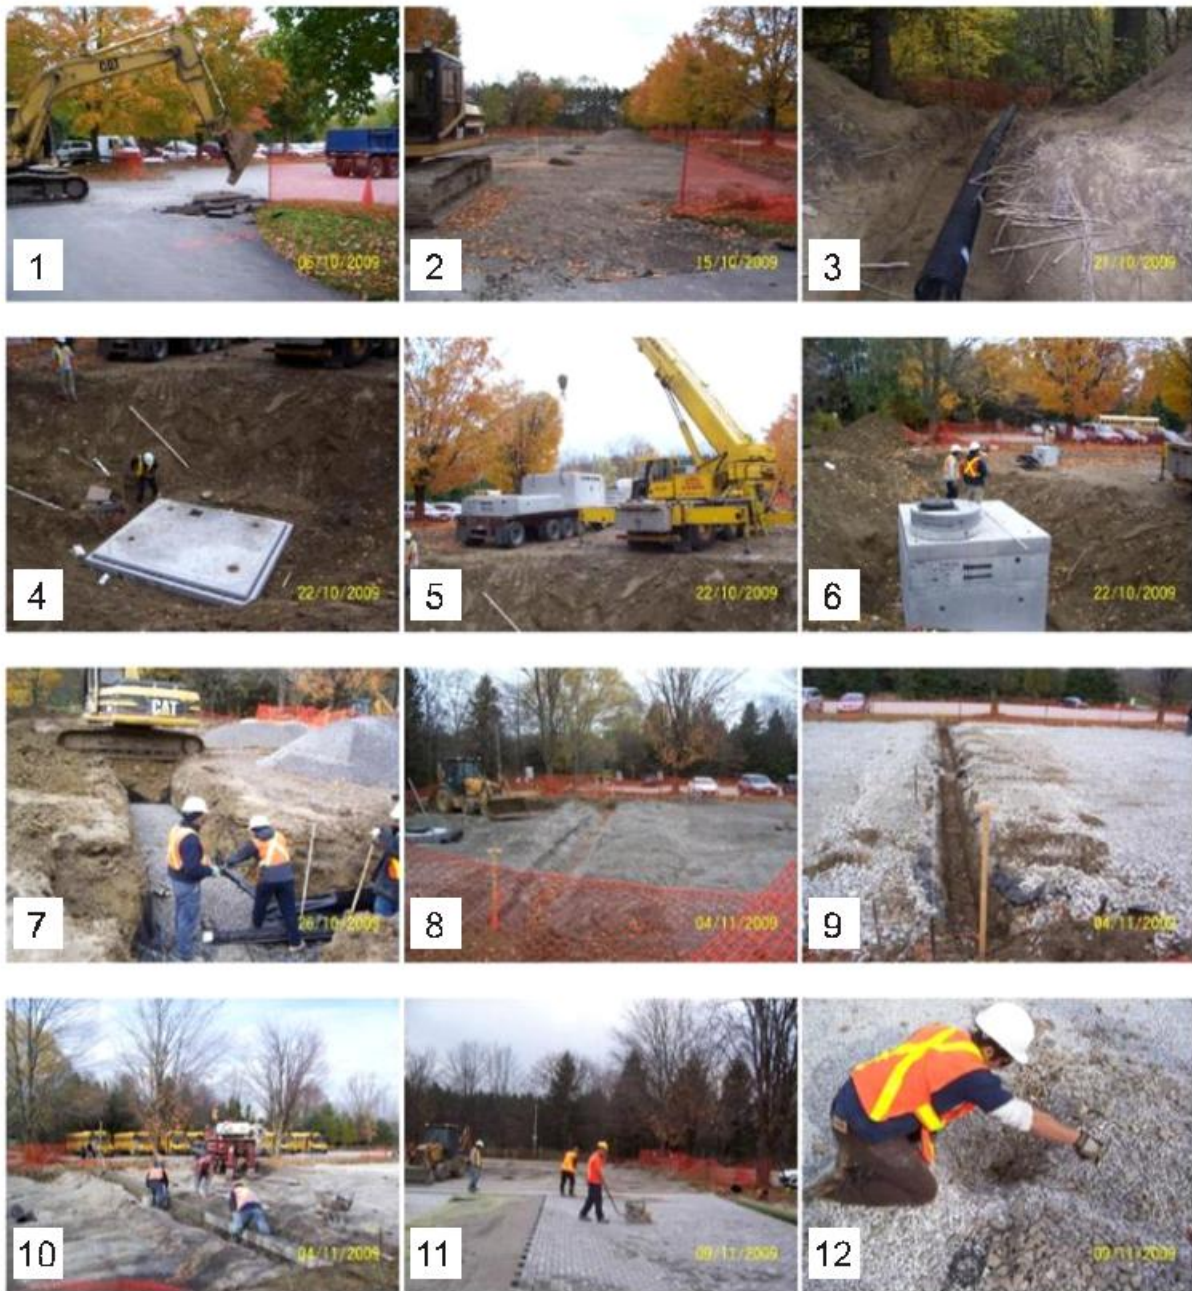
Figure A1: 2009/2010 photos

Construction of the new permeable pavement parking lot took place over the fall of 2009. The existing asphalt and fill was removed (1) and excavated (2) in preparation for the construction of the new parking lot. A drainage pipe was installed which allows runoff and water exfiltrating from the permeable pavement to discharge to the adjacent forest (3), where rip rap and a granular soakaway was installed to prevent erosion. A concrete pad (4) and vault (5) was installed which houses the equipment needed to monitor flows and collect water quality samples. The vault is accessed through a manhole and at the same elevation as the pavement so that the entire monitoring systems is gravity fed (6). With the control vault in place four drainage pipes were placed. These pipes collect stormwater from the four pavement cells. In the control cell the pipe connected to a catchbasin and drains surface runoff from the asphalt pavement. In the three permeable pavement cells the pipe is perforated and collected water that has infiltrated through the pavement and granular fill. An additional collection pipe was placed at a lower depth beneath a meter of native material under the Aquapave® PICP cell. The pipe was positioned in a trench of granular material above an impermeable liner so that water could easily drain into the pipe (7).

All four pavement cells were filled and levelled with clear stone granular material (except for the asphalt, which used a dense graded base) (8). In the permeable pavement cells this material provides up to 49 mm of storage during precipitation events. Trenches were dug between each cell (9) and a concrete curb was installed to hierologically separate the cells (10). The paving material was installed for the asphalt, the AquaPave® and the Eco-Optiloc® in early November (11). Temperature sensors were embedded in the pavement and below for the asphalt and Aquapave® PICP (12). A shallow well was dug through each pavement and transducers were installed to monitor water level responses within the pavement. Since pervious concrete required higher overnight temperatures for curing, the pervious concrete plot was installed in the spring of 2010.
