Toward Rapidly Cleaned Out Permeable Interlocking Concrete Pavers: Initial Field Tests

Bill James, CHI, Guelph, Ontario, Canada

Harald von Langsdorff, UNI-GROUP U.S.A., West Palm Beach, Florida, USA

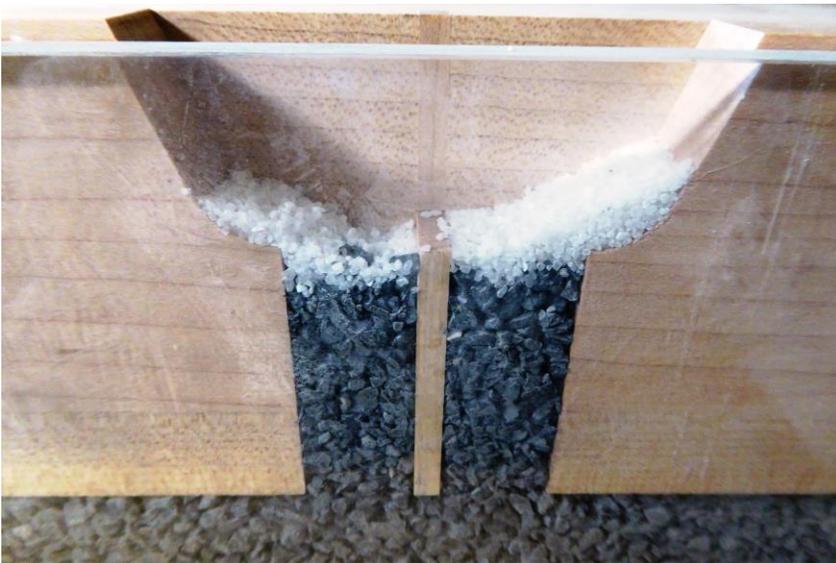
Figure 1: Typical test block enclosed in a plexiglass ampule: remnant of white aggregate in cupule, dark aggregate in conduits and bedding layer, cupule width is 12.5mm. Test cupules had sharp edges.

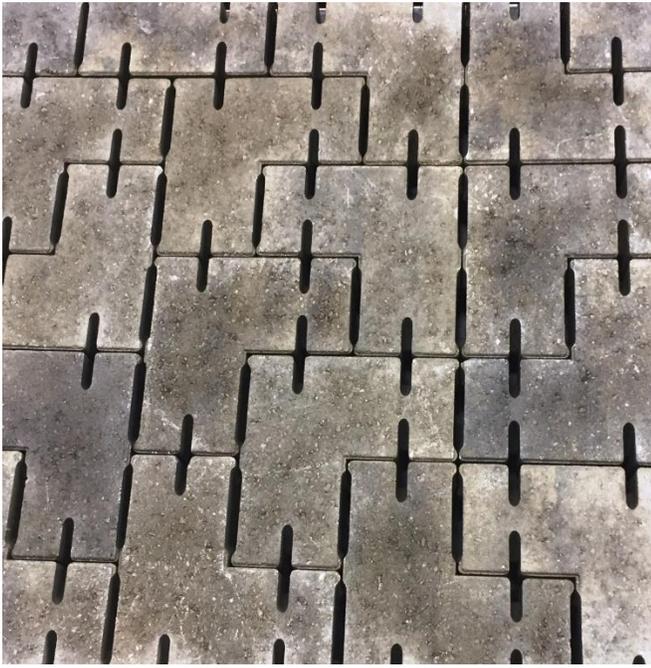
Figure 2: Pavement constructed from two L-shaped PICP blocks with cupules of two different lengths aligned in the direction of sweeper travel. Real cupules have rounded edges; cupule width is 12.5mm, block joints are typically 2 mm wide.
