# Westmoreland Pervious Pavers

## Portland, Oregon

<b>Project Type:</b>	Street reconstruction with pervious pavement—demonstration project
<b>Technologies:</b>	Pervious pavement blocks
<b>Major Benefits:</b>	<ul style="list-style-type: none"> <li>• Pervious pavement provides more natural stormwater management than a piped system, allowing stormwater to be absorbed, filtered, and cleaned before recharging groundwater.</li> <li>• Stormwater infiltration into the ground reduces combined sewer overflows to the Willamette River and reduces basement flooding caused by rain storms that overload sewers.</li> <li>• The project will provide information about how well different pavement materials, with different section geometries, manage stormwater and hold up as a street surface.</li> </ul>
<b>Cost:</b>	\$412,000, with \$80,000 paid by EPA grant funds
<b>Constructed:</b>	2004

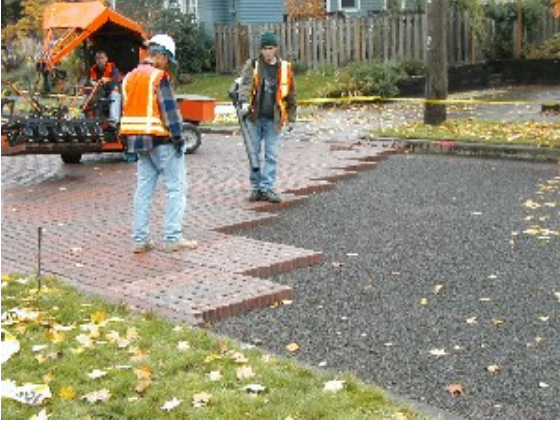
**Figure 1: Project during construction**

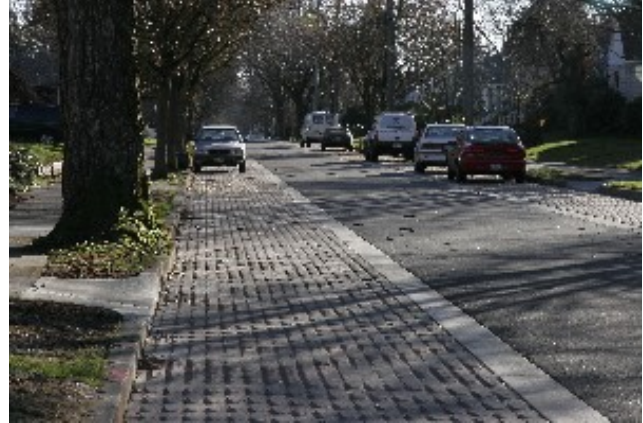
**Figure 2: Pavers along parking strips only**

- Two blocks (SE 21st from Knapp to Rex and SE Rex from 20th to 21st) were paved with pervious concrete paving blocks in the parking strips along each curb and with standard asphalt in the center strip. One block is crowned, and one is flat.

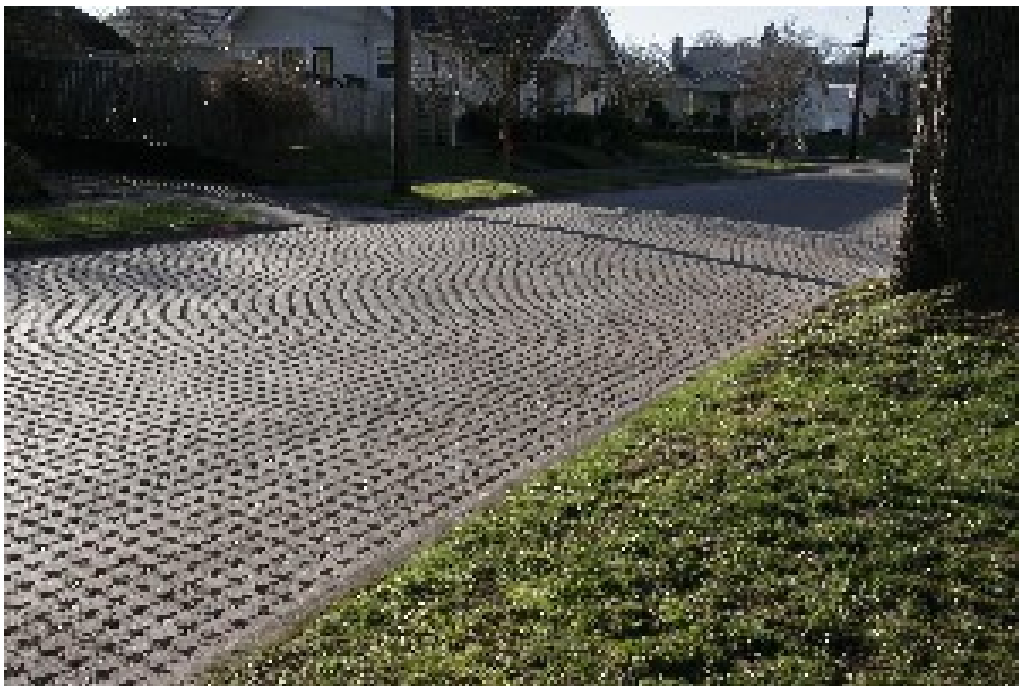
**Figure 3: Pavers along the full length of the street**

- The four blocks were repaved as follows:
  - One block (SE Knapp Street from 21st to 22nd avenues) was paved curb to curb with interlocking pervious concrete paving blocks. This block is crowned.
