GENERAL MAINTENANCE GUIDANCE

TESTING AT MORTON ARBORETUM

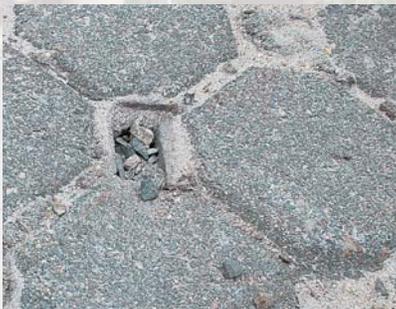
Clean aggregate is found just below the sediment trapped at the surface of the Eco-Stone openings

to 20 years old were capable of infiltrating most typical design storms despite little to no maintenance. The research also found that the small aggregate used in the openings and joints trapped sediment at the top 1 inch (25mm) or so and prevented it from entering the base and subgrade.

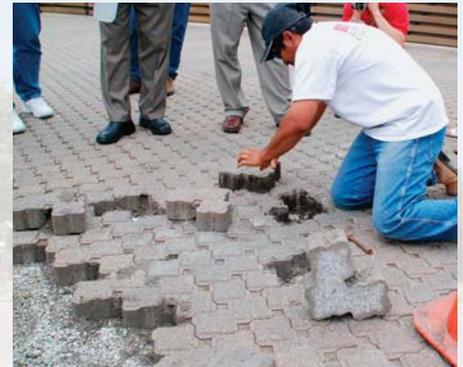
Pavers and jointing material were removed in a heavily-trafficked section to observe the penetration depth of sediments into the void and joint aggregate. As with previous research findings, the sediment was trapped in the first 1/2 to 1 inch (12 to 25mm) of the drainage voids.

Once the selected Ecoloc pavers were removed, there was no visible sediment on the bedding aggregate or the No. 57 stone base material. This clearly demonstrates the ability of the joint and drainage void aggregate to trap sediment at the surface.

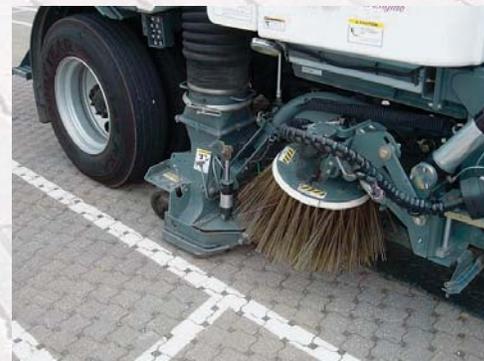
A vacuum sweeper was provided to test the ability to restore infiltration rates. The machine was adjusted to remove only the top 1 inch (25mm) of aggregate and sediment. This substantially increased the surface infiltration rate, which was demonstrated by comparing water poured on the newly cleaned surface to an

uncleaned area. After cleaning, fresh aggregate material was swept into the joints and drainage voids and the pavement surface was restored to its original condition. This demonstration

Before cleaning and after cleaning at Morton Arboretum

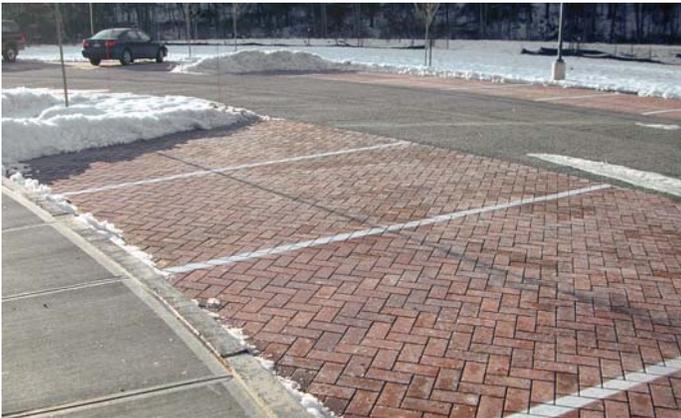
UNI permeable pavements can be snow plowed just as with any other pavement. Tests have shown a benefit of all permeable pavements is that any snow remaining after plowing can melt and drain through the surface as temperatures rise, thus reducing or eliminating refreezing of water at night and reducing slip and skid hazards. In addition, research at the Toronto and Region Conservation Authority and the University of New Hampshire has shown that the use of deicing salts can be reduced with permeable pavements. This provides added environmental benefits. Winter sanding of PICP is not recommended as it will speed up clogging. Instead, if needed, use No. 8, 89 or 9 stone for traction as these materials are typical of jointing and drainage opening fill.
